NRL Project 62R05-19B

Technical Memo No. 233

ULTRASONIC INSPECTION OF TUNGSTEN ROUND ROBIN BILLETS, PHASE III

27 May 1963

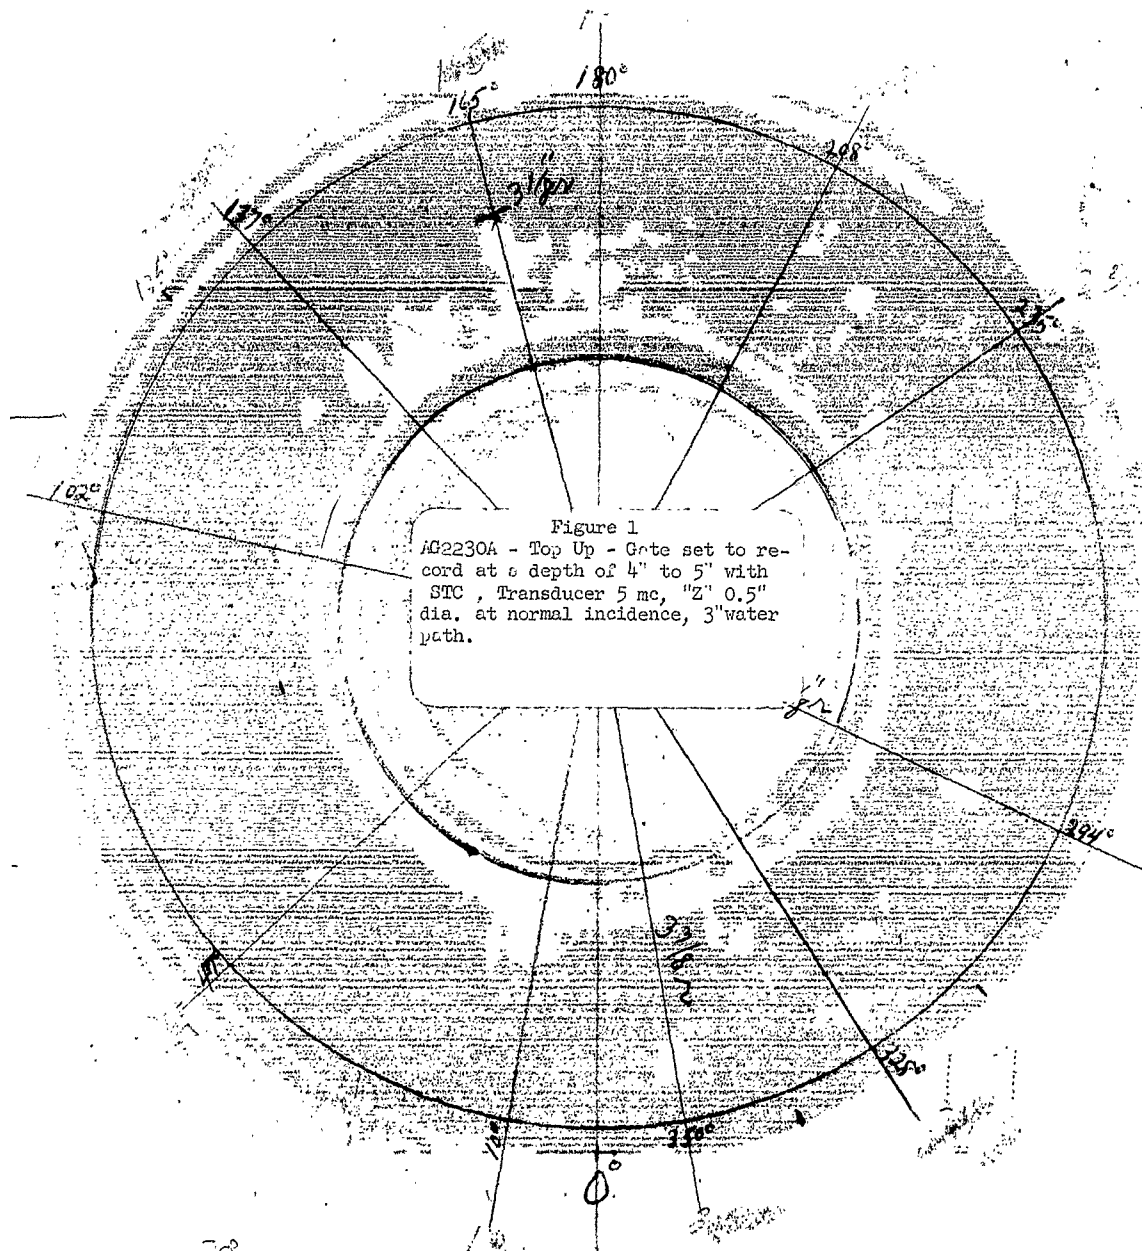
In order to eliminate the necessity of continuous monitoring of the equipment to determine defect depth, the gating and recording circuit were adjusted in increments of one inch. As can be seen in Figure 1, much time was saved since the majority of the "defects" appeared at a depth of 4 to 5 inches.

The billet was also inspected bottom up. The only defects found were at a depth of 3.5 to 5 inches from the bottom. Figure 2 is a recording of the various defect areas. An interesting feature of the test results is the amount of "edge effect" which is very obvious in Figures 1 and 2. This is due to a slight machined bevel which was on both the inner and outer diameters of both ends of the billet. Actually, we did use the electrician's tape technique which we described in the Phase I Report<sup>1</sup> but the bevel introduced some additional edge effect.

The only defects which we found equivalent to or greater than a #5 FBH were the two cracks in AG2231A. Defects in AG2230A actually found to be equivalent to a #3 FBH were located at 10, 150, 165, 180, 210, 220, and 290 degrees. These were found shooting at normal incidence, top up. (Figure 1). All other defects were smaller in amplitude but large enough to record.

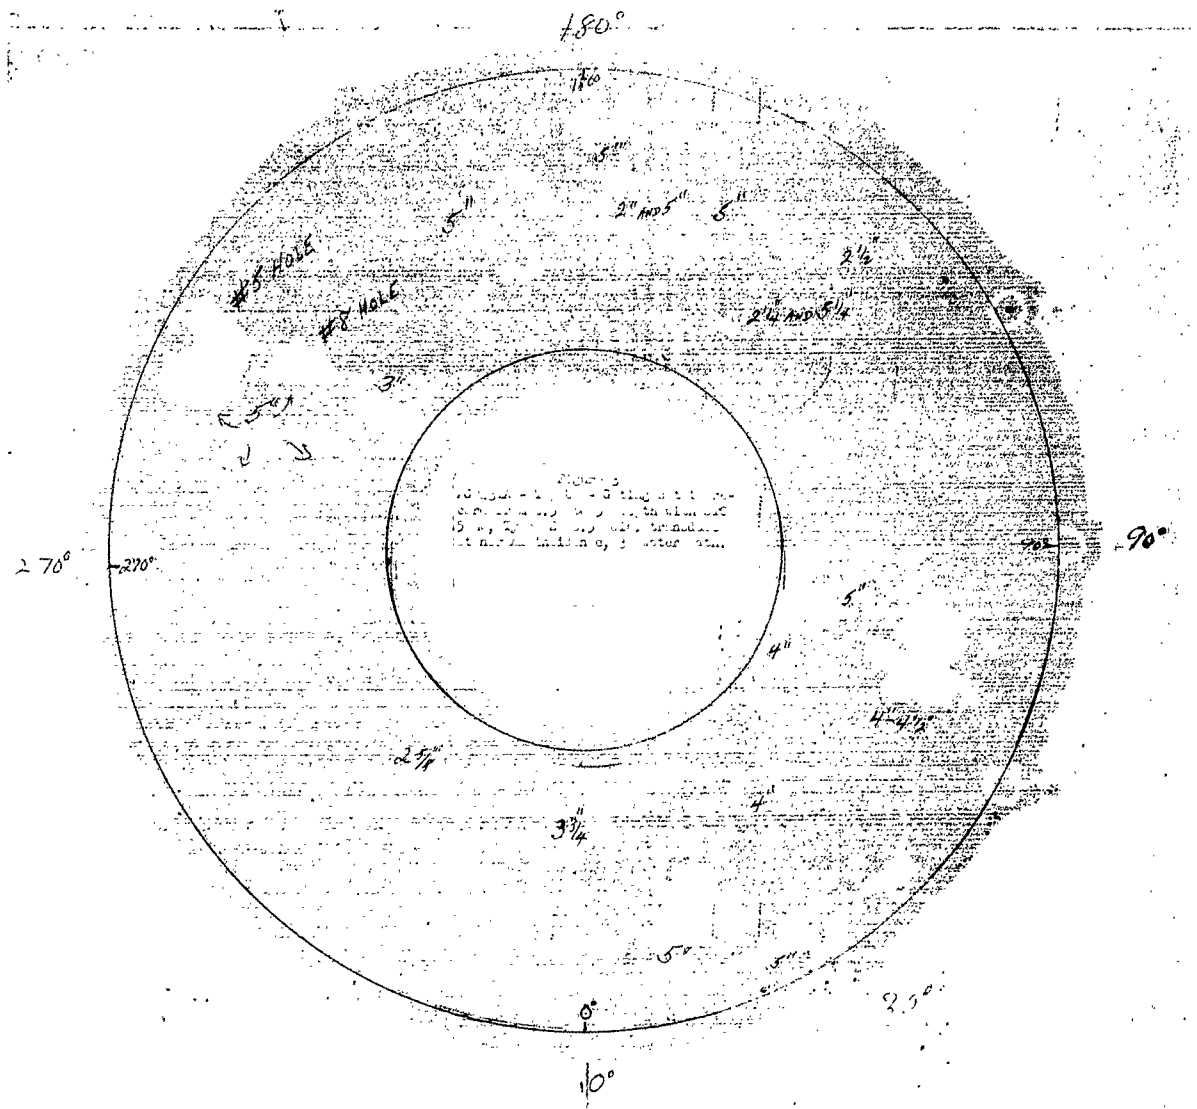
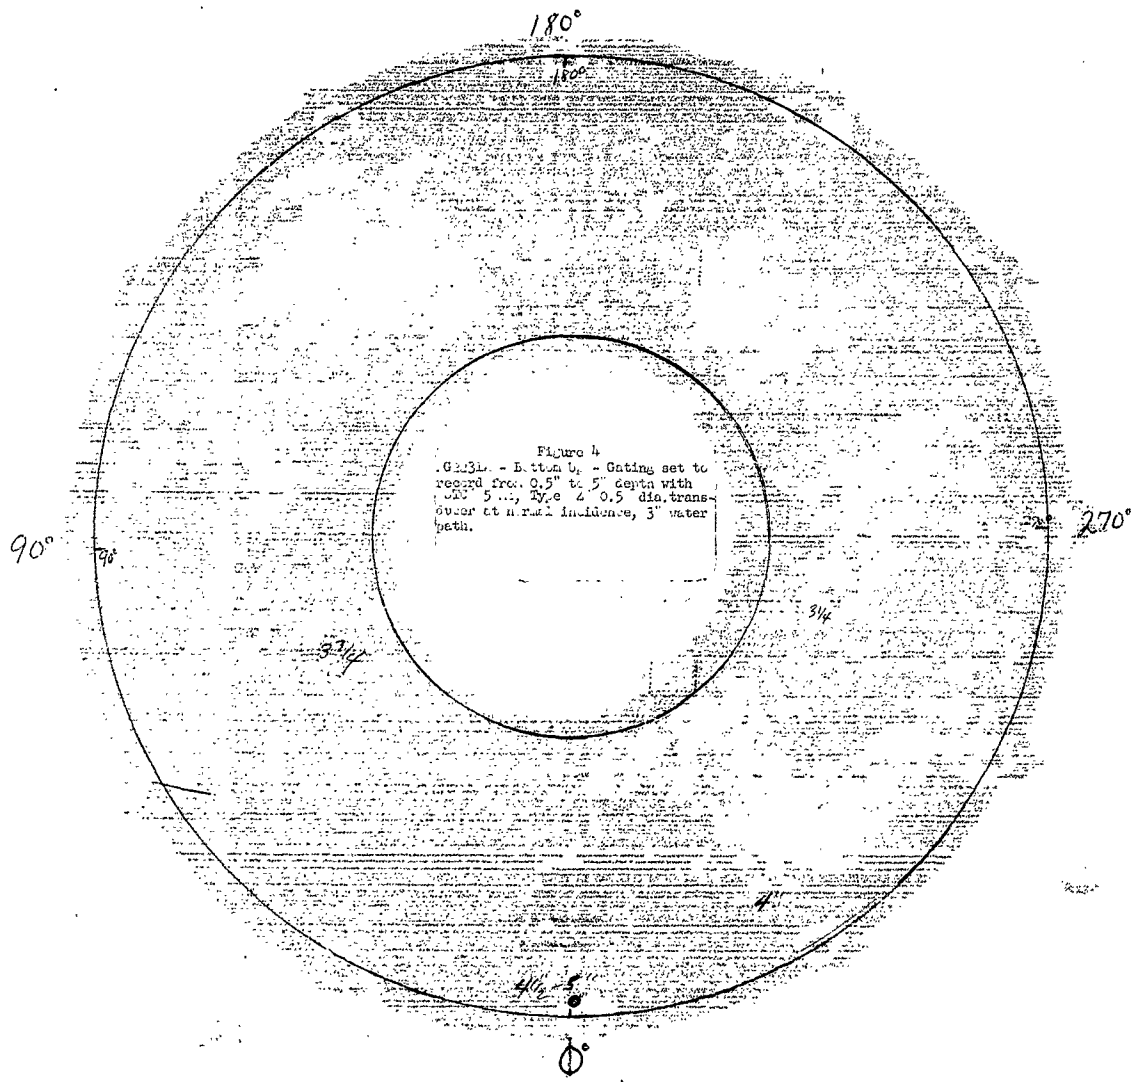
This billet was inspected in a manner similar to that of AG 2230A. Namely, top up and bottom up. Figures 3 and 4 show the actual inspection results. To save time, the flaw gate was set to record all defects of sufficient amplitude from a depth of 0.5 inches to 5.0 inches, rather than in depth increments of one inch. In addition, binder head screws were taped around the circumference of the billet at  $30^\circ$  increments to obtain a more accurate location of "defective" areas. These can be seen in Figures 3 and 4 as circular outlines. This is a much more accurate means of flaw location on round billets. If one had a number of these billets to inspect, a hinged prefabricated plastic appliance could be made to fit around the circumference of the billet. This would not only facilitate flaw location, but it would also help reduce "edge effect".

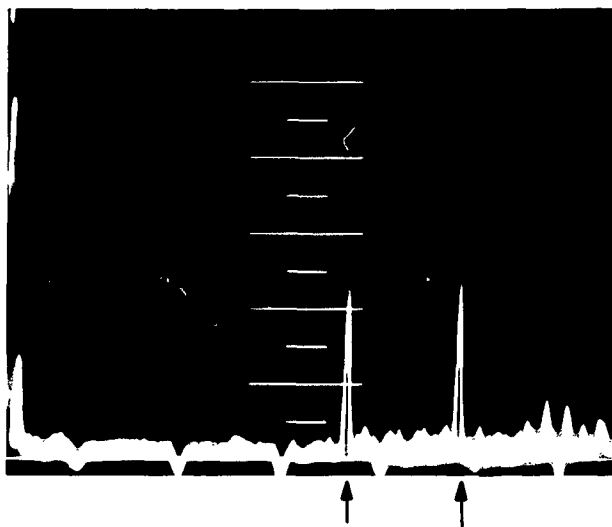
Several photographs of the observed oscillograms were taken to clarify statements made in this report. Keep in mind that the Immerscope sensitivity was set to obtain 100% signal amplitude from a #3 FBH, but the recording level was set to record at a 50% amplitude level. This is necessary in order to obtain recordings of marginal defects. Figure 5 shows an area at 15° in AG2230A. Two distinct defects can be seen at depths of 3.6 and 4.8 inches. Since both defects are less than 50% amplitude, neither would be recorded. Now refer to Figure 6 - on the same scan at an angle of 10°, one defect is increasing in amplitude as the other

Fig 5 - Defects in AG2230A at  
15° at depth of 3.6" and 4.8"

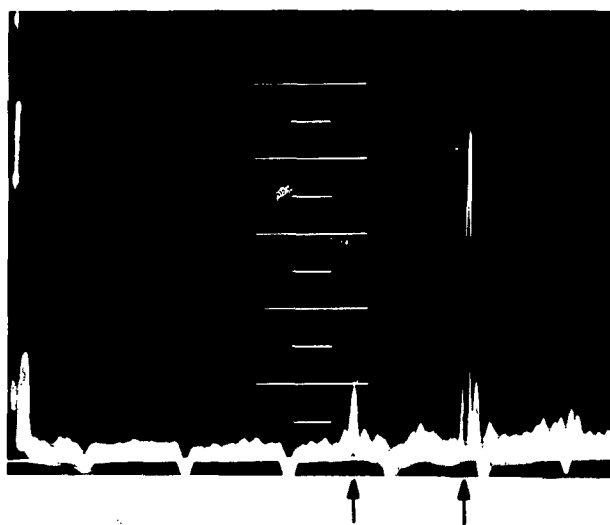
is decreasing. The larger amplitude signal is not recording. If an indexing increment of 0.050 inches or less is used, the defect will clearly show on the recording, but if larger indexing increments are used it could be easily missed. A good "rule of thumb" is that the smallest defect area to be detected, should be recorded on a minimum of three successive index increments.

Fig 6 - Same defects as above  
but at 10°

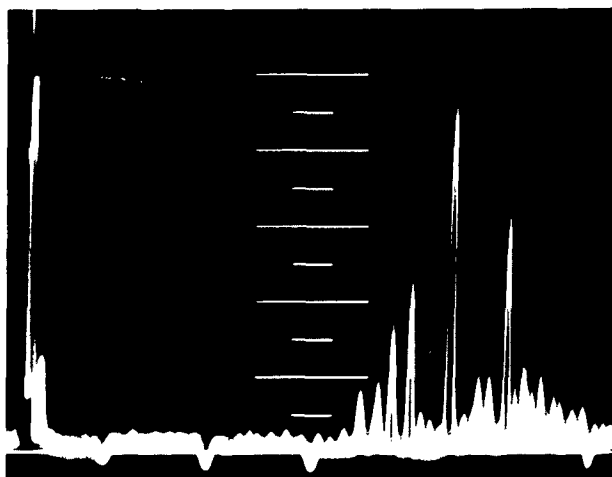
Since the word "crack" is not very scientific, Figure 7 will possibly help define it. This is an oscillogram of an area in AG2230A at 210°. Note the varying amplitude and baseline noise.

Fig 7 - Area in AG2230A at 210°

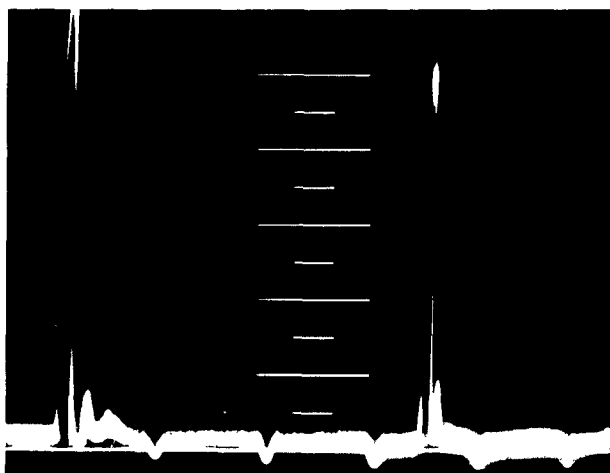
Figure 8 shows a real nice "defect" in AG2230A at 180° at a depth of 3.5 inches. It is really an accidental "booby trap" which can throw an inspector behind schedule. This was an air bubble on the O.D. of the billet. Only a very small section of the 0.5 inch transducer was beyond the edge of the billet. By the way, it was equivalent to a #5 FBH.

Fig 8 - Air bubble at 140° on  
AG2230A

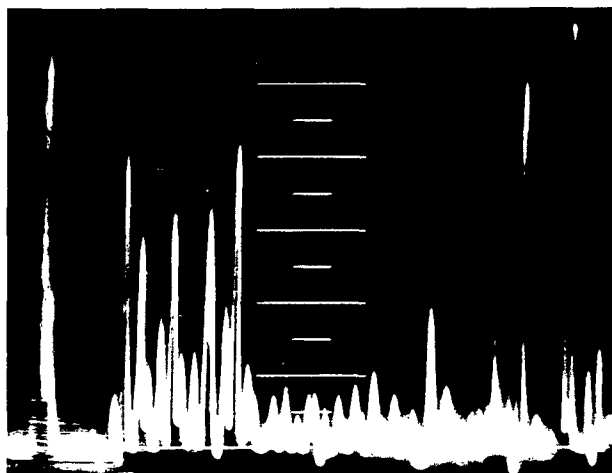
e. The advantage of using "SGC" can readily be seen when a comparison of Figures 14 and 15 is made. The Figure 14 oscillogram shows a series of defects at a depth of 1 to 2 inches in the AGC reference standard when we had adjusted our equipment for 100% reflected signal amplitude of the #3 FBH, 5 inches from the top surface. The Figure 15 oscillogram was taken with the "SGC" in the circuit. Notice that the "defects" which in Figure 14 appeared to be equivalent to a #3 FBH no longer exist.

Fig 14 - #3 FBH 5" down in AGC  
Reference Standard, Immerscope  
with no "STC"

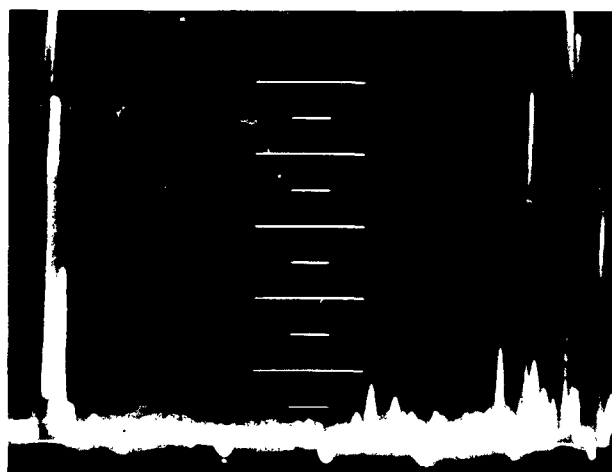
Fig 15 - #3 FBH 5" down in AGC  
Reference Standard, Immerscope  
with "STC"
